This spreadsheet performs screening level calculations to estimate the effect of peeling leaded paint on the average concentration of lead in yard soil
3762 Marion St.

Property ID: 506	Date: 8-17-05
Address: 3762 MARION STREET	Telephone #:
Owner:	CO Certification #: 12860
Inspector/Assessor:

LBP Assessment Results

Property ID # 506 / 3762 Marion Street

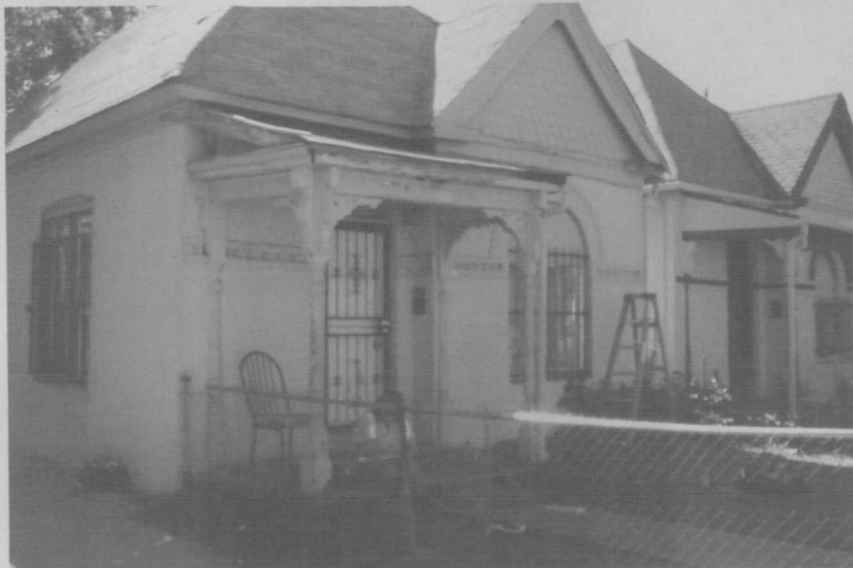
West porch exposure of house

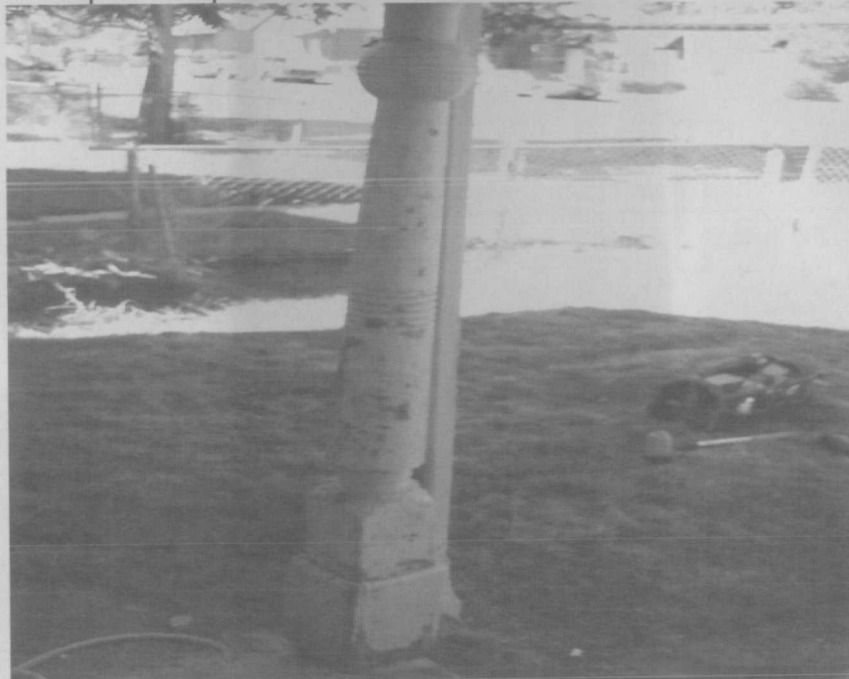
Wood porch column contains peeling lead paint

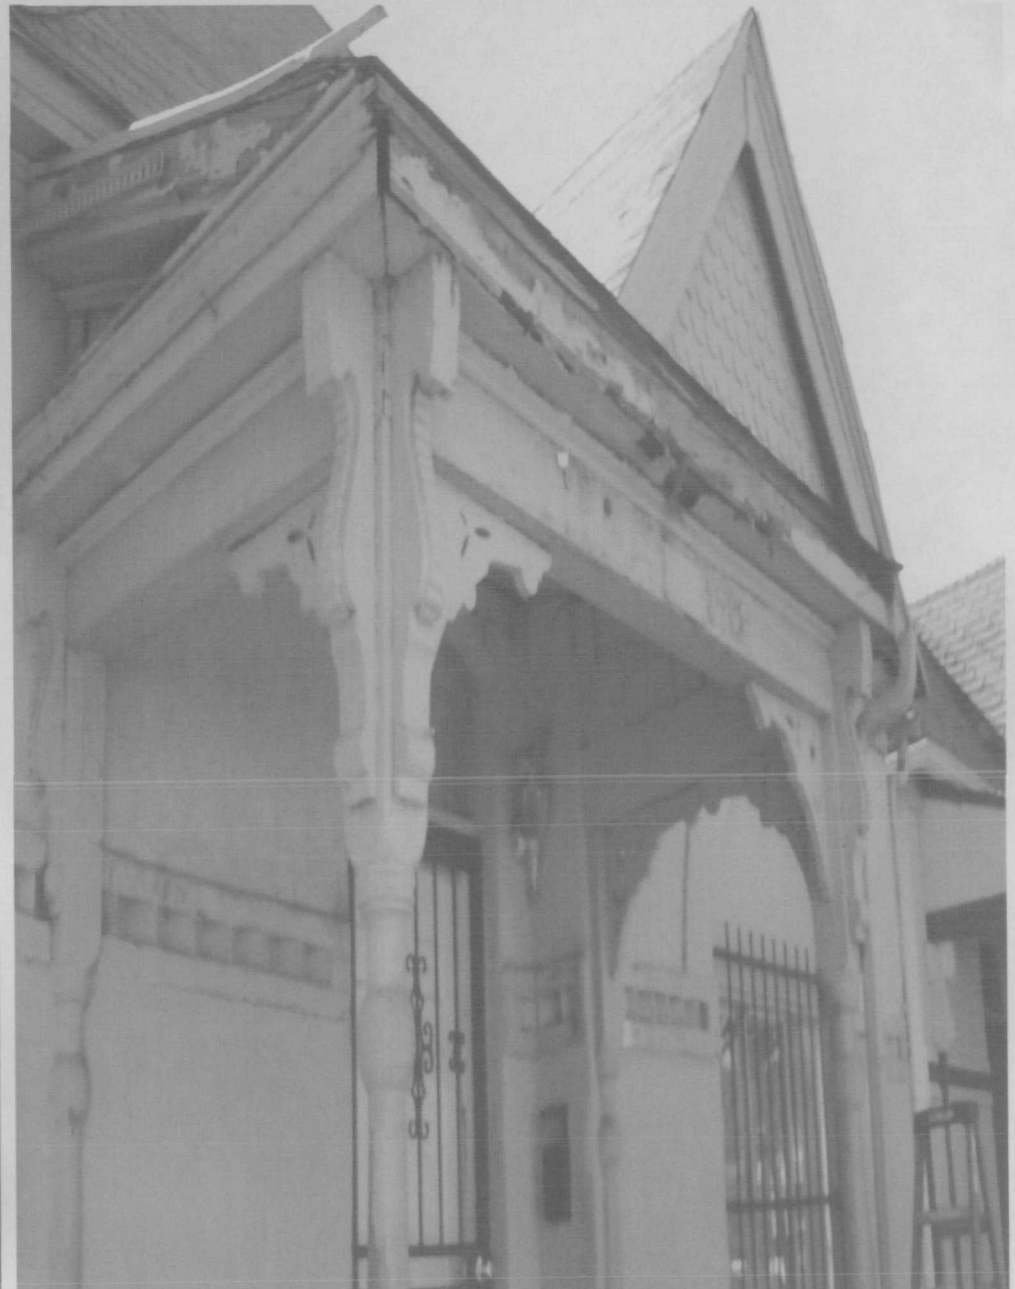
Wood soffit / trim on west exposure of porch contains peeling lead paint

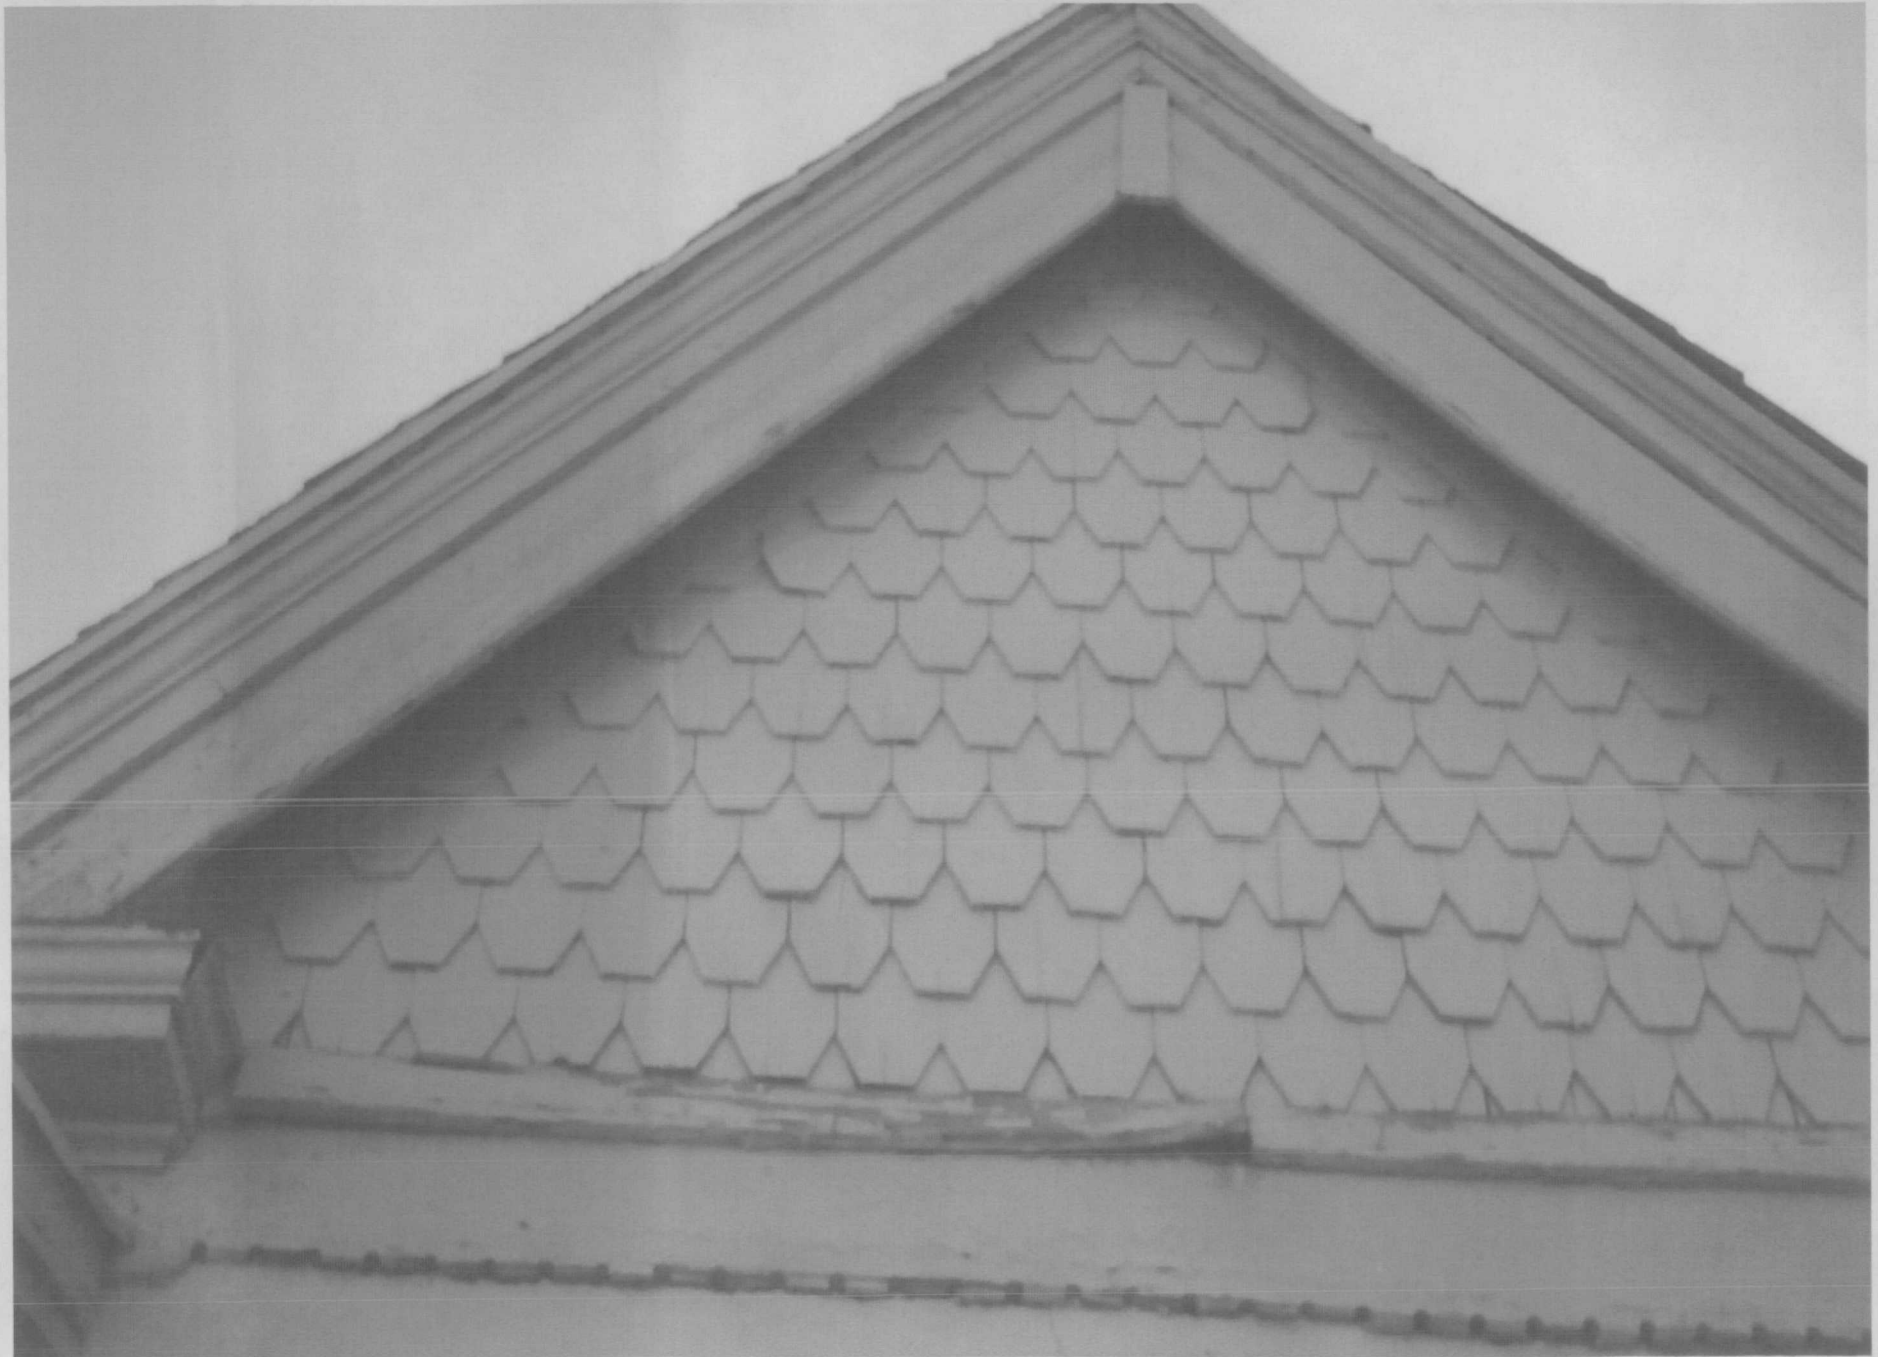
Property # 506: Peeling lead paint on attic trim contains peeling lead paint
